# WATER SAFETY PLAN : FINDINGS AND LINKS WITH WASTEWATER MANAGEMENT

16 OCTOBER 2017

# CL2 Dosing Process, Timor Leste, 2017

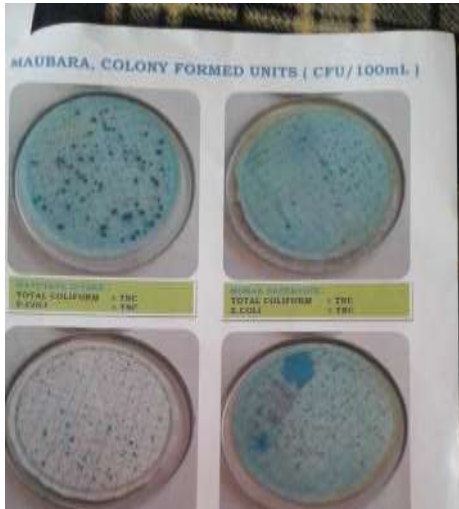
Source contamination

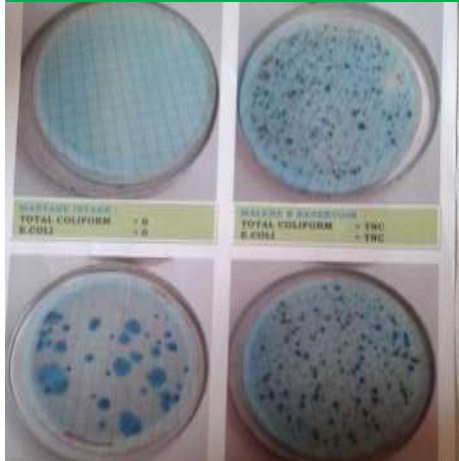
Un safe reservoir

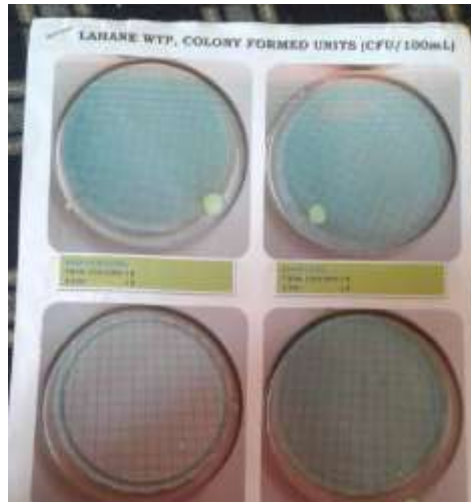
Safe system

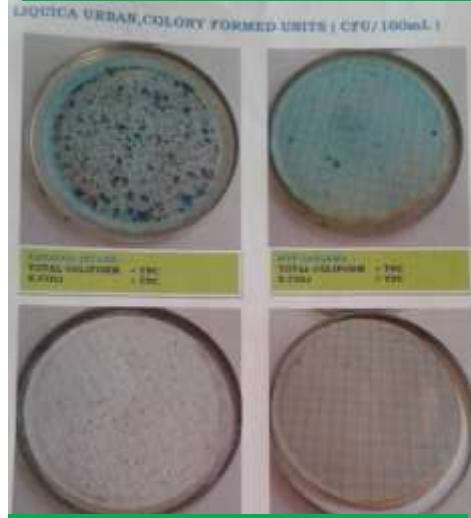
Partial treatment

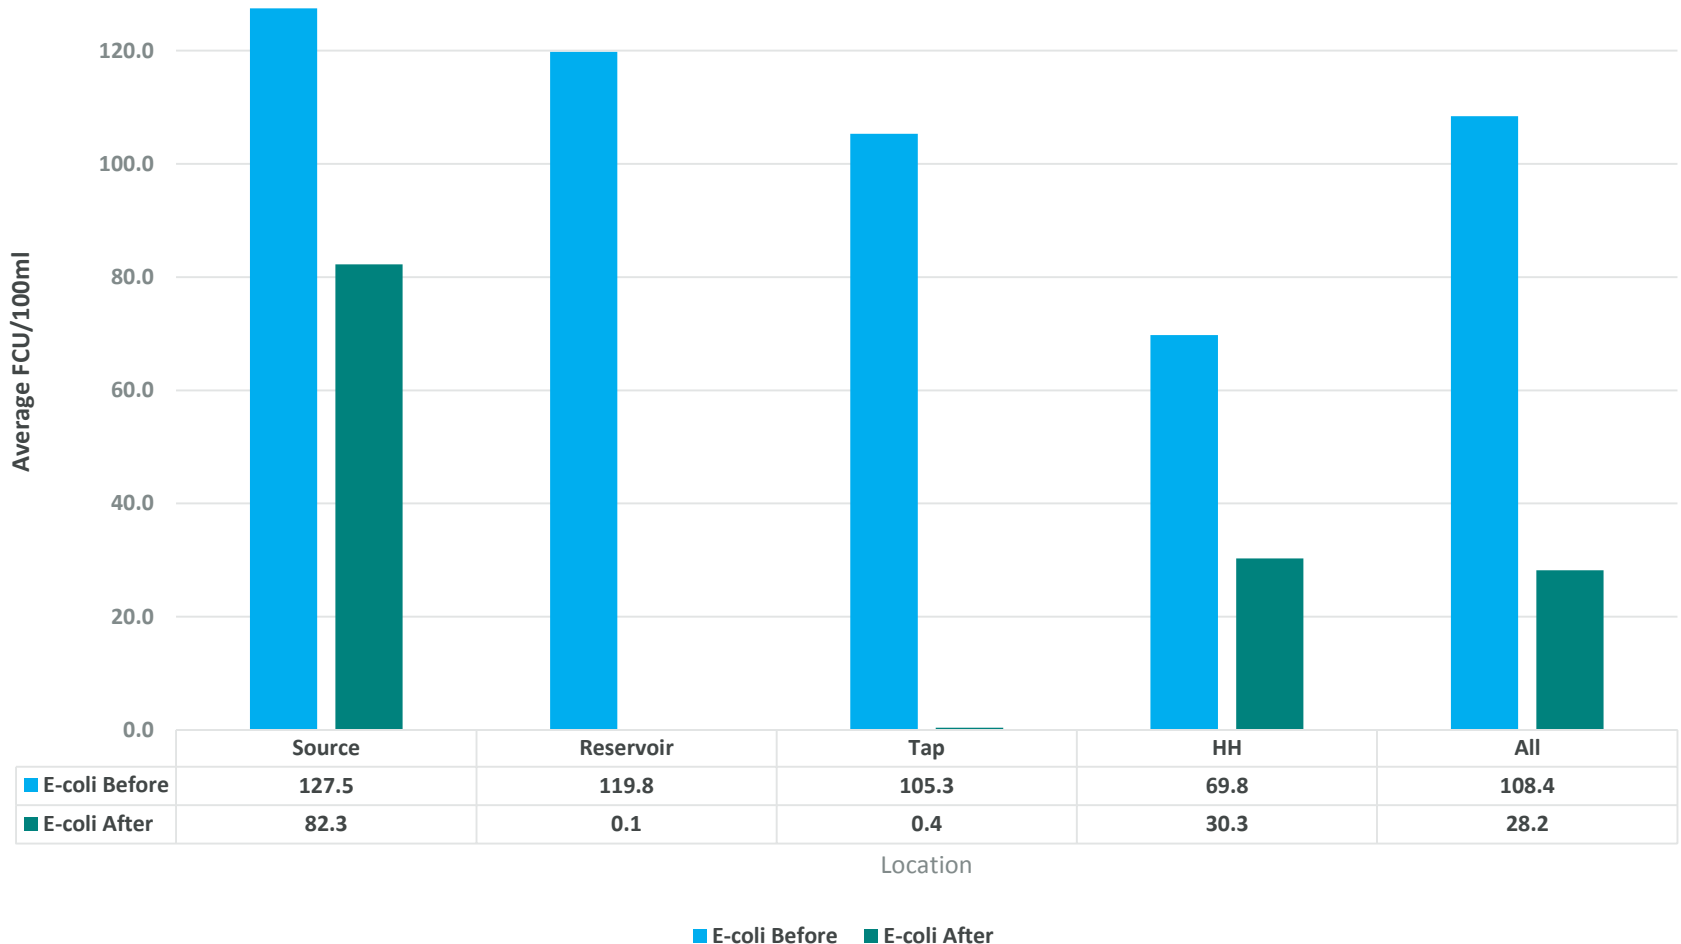
E-coli distribution before and after WSP

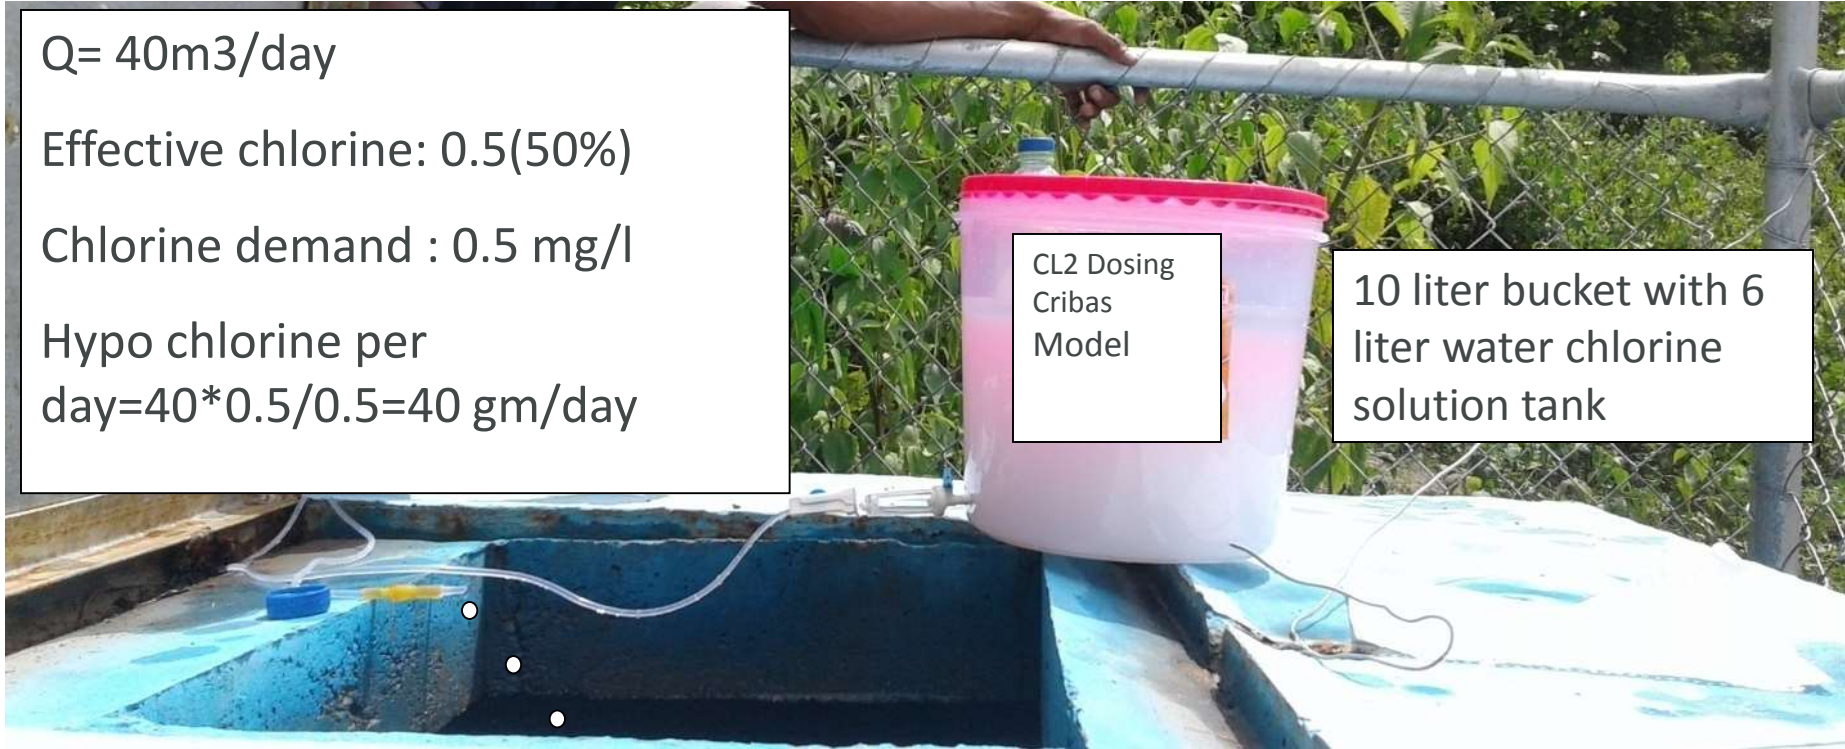
CL2 Dosing  
Cribas  
Model

# Chlorine dosing flow diagram

$Q = 40 \text{ m}^3/\text{day}$

Effective chlorine: 0.5(50%)

Chlorine demand : 0.5 mg/l

Hypo chlorine per  
day =  $40 * 0.5 / 0.5 = 40 \text{ gm/day}$

10 liter bucket with 6  
liter water chlorine  
solution tank

Flow = 4.2 ml/min

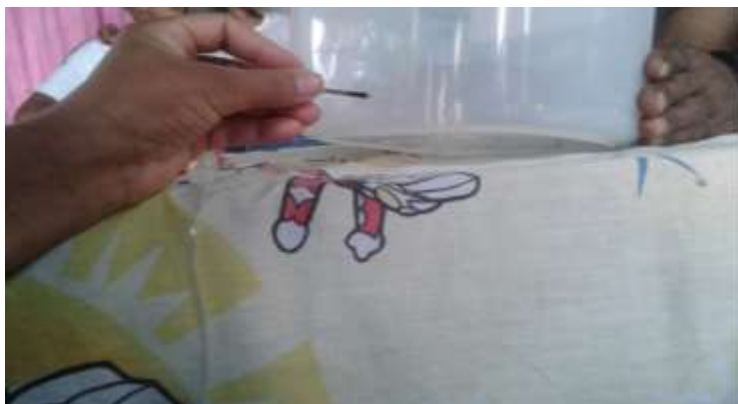
Make a hole in Plastic bucket slightly smaller than head of slain pipe.

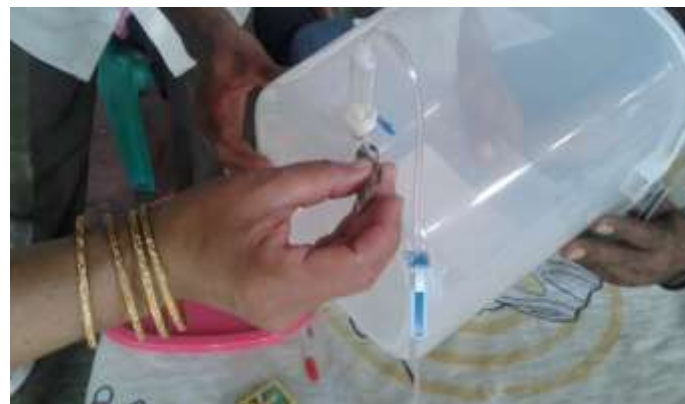
Fit Head of Slain pipe in to the plastic bucket . Apply super glue for safety

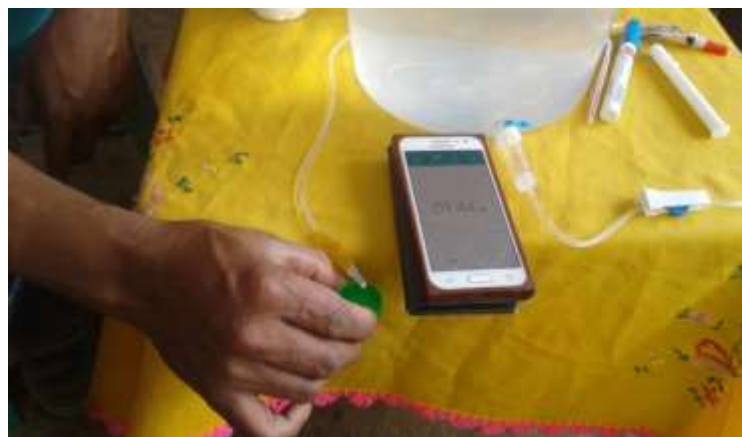
Adjust flow from the slain pipe with regulator and measure flow.

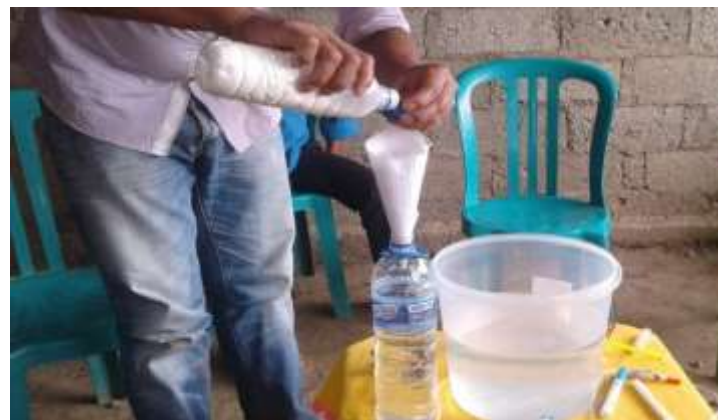
Add required CL2 powder in a Aqua bottle
